CABIN JOHN CREEK WATERSHED ASSESSMENT AND MANAGEMENT **RECOMMENDATIONS**

FINAL REPORT

ENVIRONMENTAL MANAGEMENT DIVISION DEPARTMENT OF PUBLIC WORKS CITY OF ROCKVILLE, MARYLAND

Approved July 18, 2011

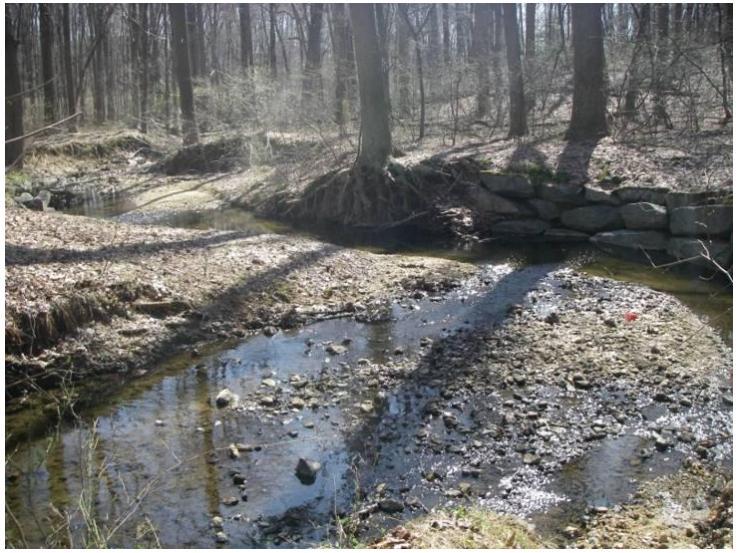
The mainstem of Bogley Branch was broken up into three unique assessment reaches based on habitat conditions (Reaches 001, 004, and 006). There are also three tributaries draining into the mainstem of Bogley Branch (Reaches 002, 003 and 005). Detailed reach write-ups are included in Appendix H.

FIGURE 14: RIP-RAP ARMORING (REACH BOG-004)

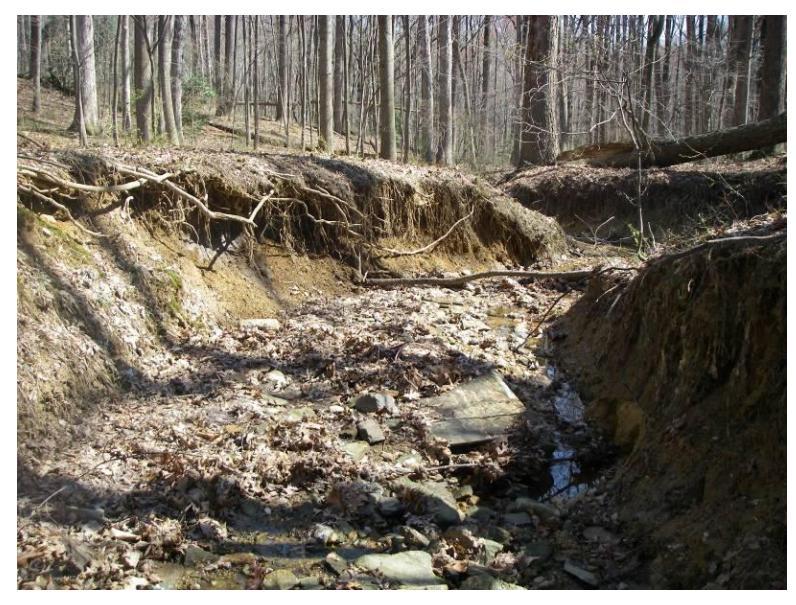
Tributaries draining to the mainstem reaches are generally stable with the exception of Reach 005 which is experiencing severe erosion and active headcutting along the entire reach. Low flow, shallow depth and poor habitat make the tributary reaches unsuitable as fish habitat.

FIGURE 15: SEVERE BANK EROSION (REACH BOG-005)

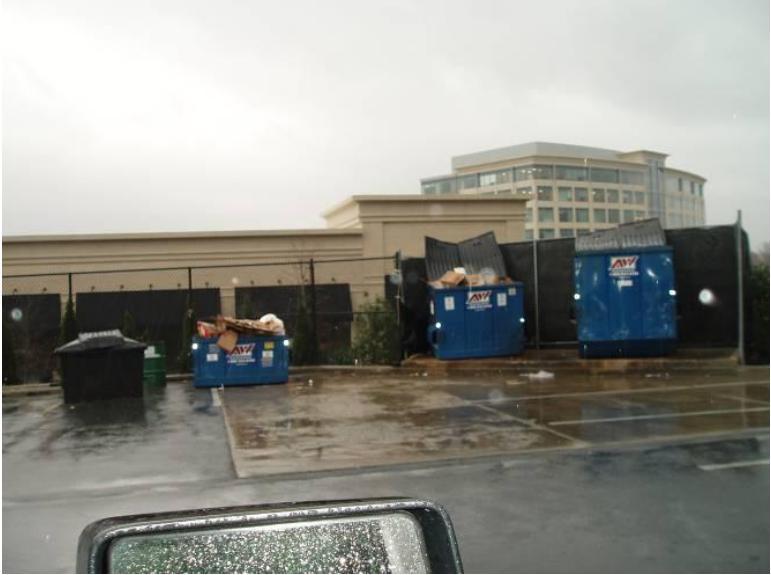
Another hotspot site, the Seven Locks Maintenance Yard for the Highway Services Division of the Montgomery County Department of Transportation, also drains to both Bogley Branch and Lower Cabin John sub-watersheds. Its HSI assessment is included under the Lower Cabin John section. The maintenance yard was a confirmed hotspot for leaking vehicles, overflowing dumpsters and poor parking lot condition.

FIGURE 18: OVERFLOWING DUMPSTERS (H-102)

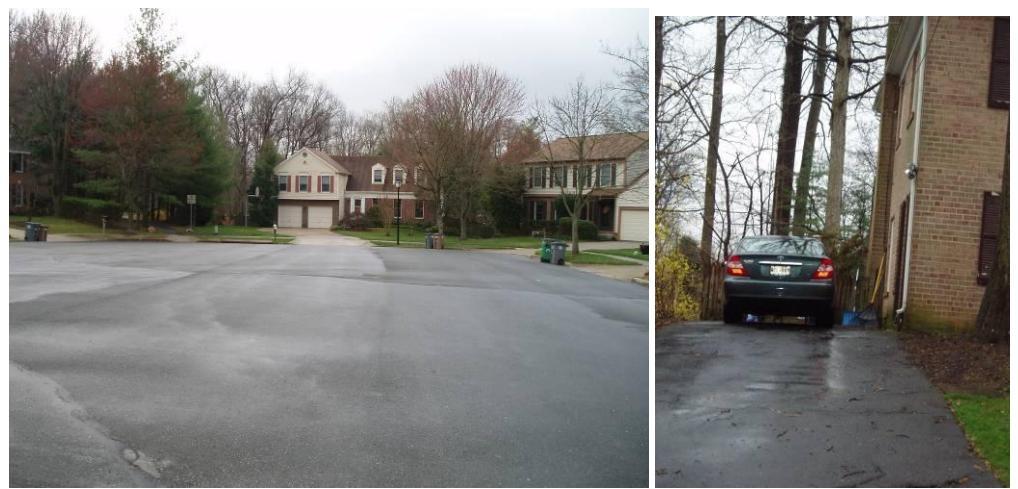
The five neighborhoods surveyed in Bogley Branch all consisted of single-family detached structures on 1/4 to 1/3 acre lots, classified as medium-density residential land use. They were well established areas constructed primarily in the 1960s, 1970s, and 1980s. Very little infill or redevelopment was observed. Lawns in all the NSAs were characterized as having medium- or high-maintenance, indicating higher rates of fertilizer or pesticide use that can impact stream quality. Downspouts were 80 percent disconnected (i.e., discharging onto vegetated areas instead of paving) in the two newer neighborhoods, and 35 – 50 percent disconnected in the three older areas. Some roof drainage was connected directly or indirectly to the storm drain system. Parking lot and street stormwater is conveyed through curb and gutter, then to inlets, and finally to a closed storm drain system. No inlet stenciling or marking was observed.

FIGURE 19: EXCESSIVELY WIDE CUL-DE-SAC (N-101); DOWNSPOUT INDIRECTLY CONNECTED TO THE STORM DRAIN (N-102)

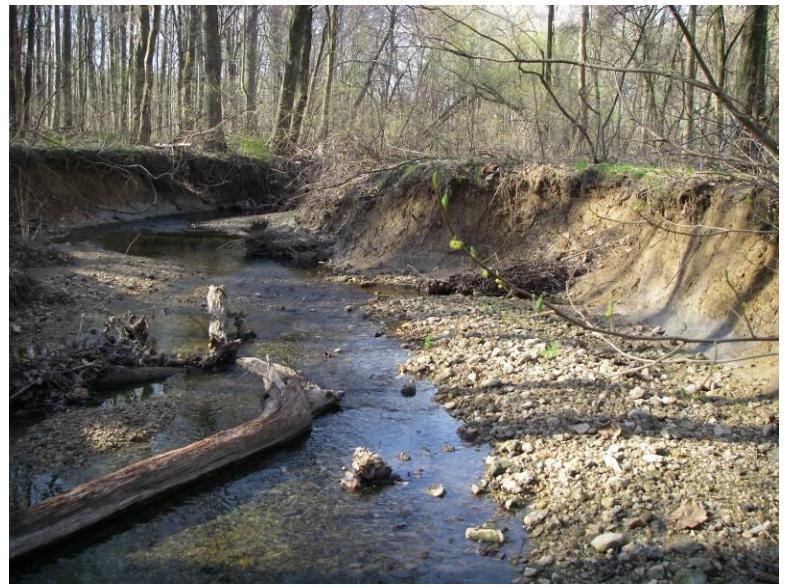
The mainstem reaches for the Dawson Farm Creek sub-watershed can generally be characterized as incising with erosion occurring along the outsides of meanders. Gravel and sand point bars are common throughout the mainstem with areas of bedrock and exposed clay substrate. Eroded sediment is filling in available pools. Many of the reaches in this sub-watershed are constrained by existing infrastructure. There are large areas of channel straightening and stabilization, specifically along Reach 003, paralleling Wootton Parkway.

FIGURE 22: INCISED CHANNEL WITH GRAVEL POINT BARS (REACH DFC-002)

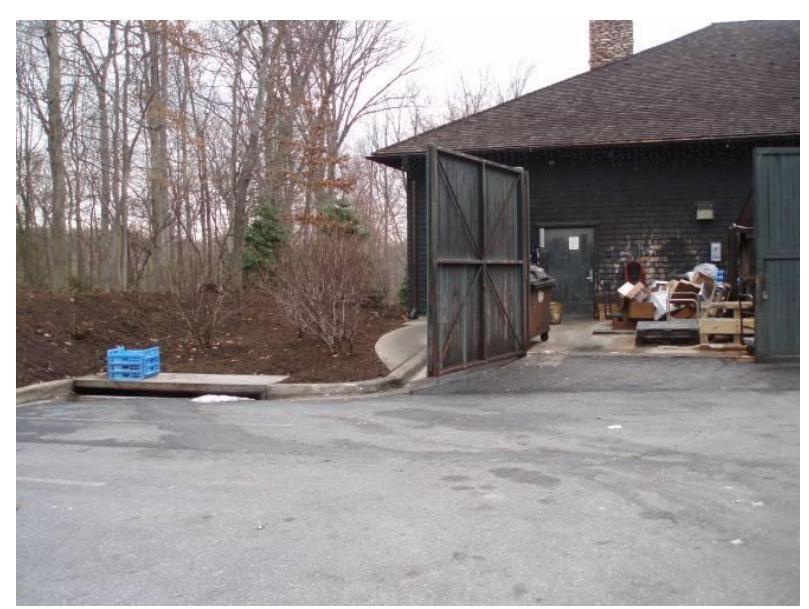
Six hotspot sites and eight neighborhoods were assessed in Dawson Farm Creek. Five of the six hotspot sites were commercial areas and the sixth was an institutional use. The only hotspot activity noted was related to waste management, there were no vehicle operations or materials handling at any of the sites. Problems with waste management were noted at most of the sites, with either overflowing dumpsters or loose trash. A potential illicit discharge was found at site H-306, and evidence of discharging washwater into storm drains was seen at site H-308. Site H-300 was rated as a confirmed hotspot and all the others were rated low severity.

FIGURE 25: EVIDENCE OF WASHWATER DUMPING INTO STORMDRAIN SYSTEM (H-308)

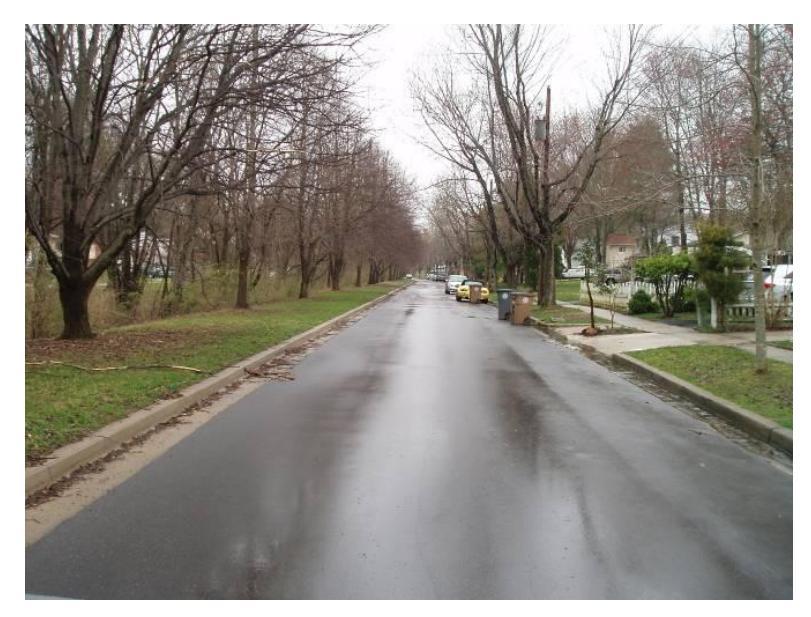
With one exception, downspouts were more disconnected in the older neighborhoods. Stormwater was conveyed through curb and gutter to inlets. No inlet stenciling or marking was observed. All the areas except one were rated moderate for both pollution potential and restoration opportunities.

FIGURE 26: TYPICAL NEIGHBORHOOD CONDITIONS (N-129)

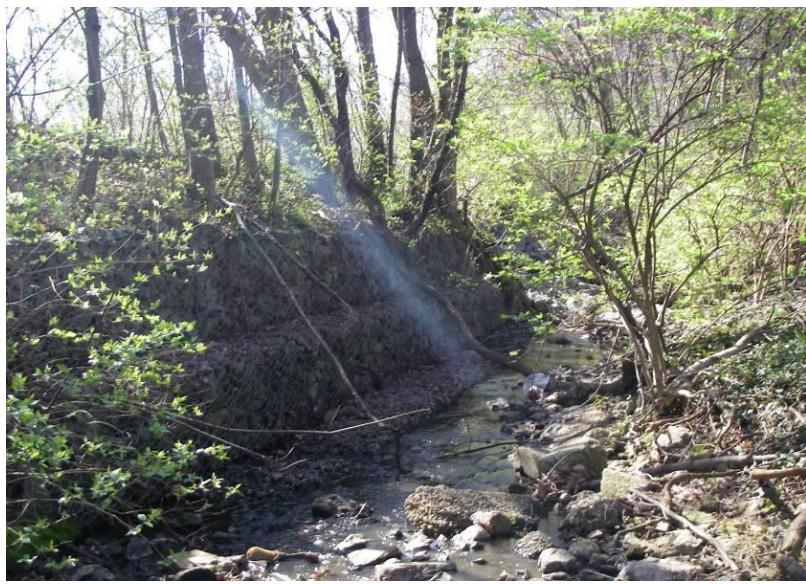
Generally, streams in the Elwood Smith Tributary sub-watershed are relatively stable with sections of active erosion. The overall assessment of the reach was that the active widening was the dominant process. Several outside meanders on Reach 001 have been armored and are in stable condition. Riparian buffer width varies along the length of the channel from good to poor and invasive species are prevalent. Stream habitat is in the mid-marginal to low-suboptimal range and the culvert at the downstream end of the mainstem (under Cabin John Parkway) is a fish blockage for all upstream reaches.

FIGURE 29: STREAMBANK ARMORING (REACH EST-001)

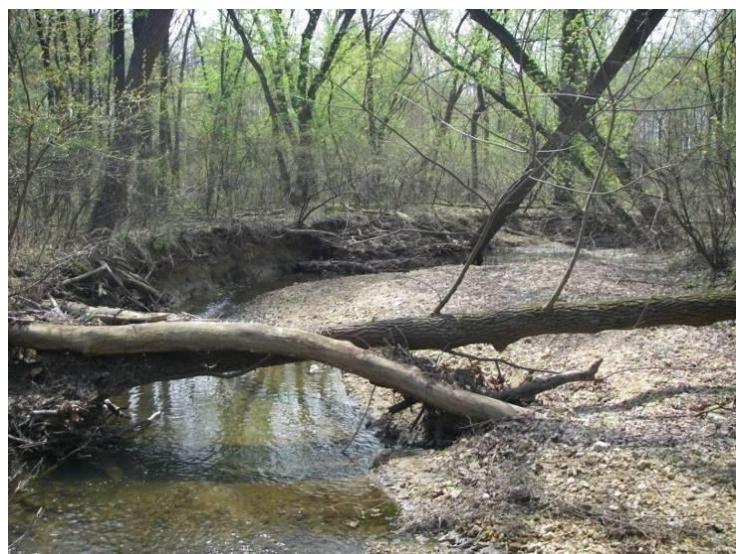
The mainstem reaches of the sub-watershed are moderately eroded and actively widening. There are areas of severe erosion along several outer meanders with sediment deposition in the form of gravel and sand bars on inner meanders. In addition to this natural erosion, human impacts on Reach 001 are severe. A person was encountered during the field work using a shovel to cut off existing meanders thus straightening the channel. This disturbance has occurred along approximately 700 feet of the reach. (City staff were not able to find this person after the report of his illegal activities.) Habitat for the mainstem reaches are in the low-suboptimal to high-marginal range with areas of heavy algae. Riffles and pools are the dominant habitat.

FIGURE 34: GRAVEL POINT BAR AND WIDENING CHANNEL (REACH LCJ-001)

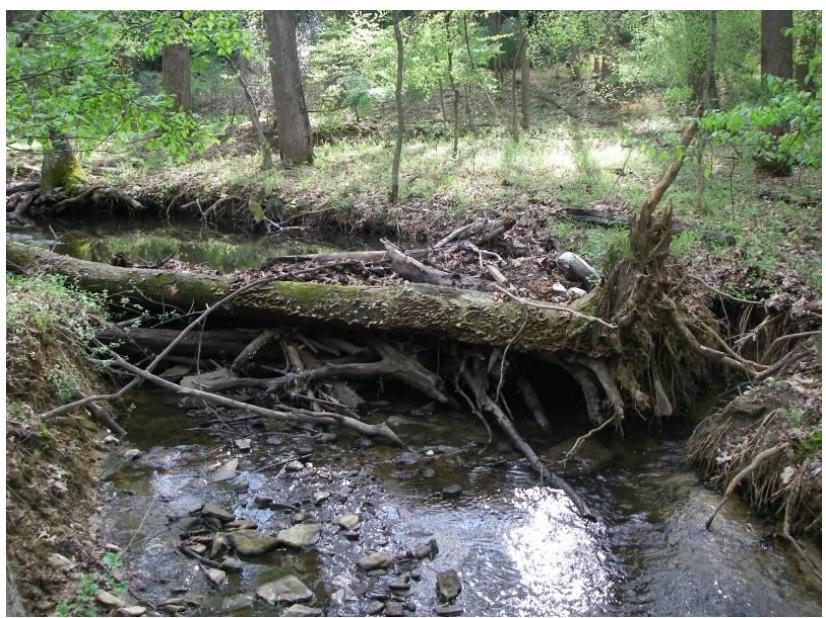
FIGURE 39: DEBRIS JAM CONTRIBUTING TO EROSION (REACH OFC-015)

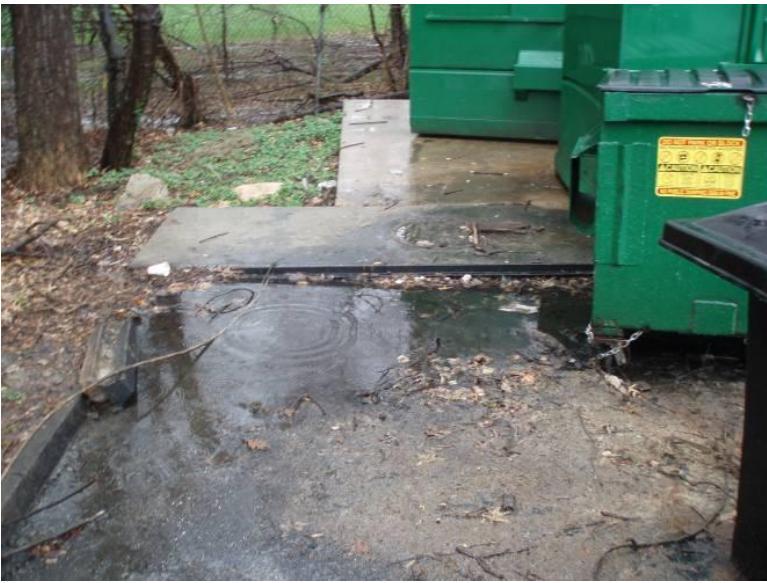
FIGURE 42: OVERFLOWING GREASE TRAP (H-302).

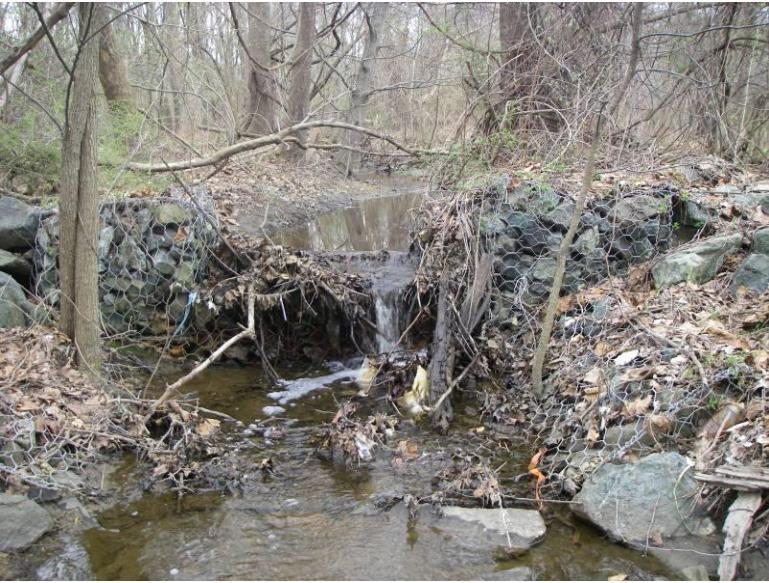
FIGURE 45: IN-STREAM GABION WEIR (REACH SLT-005)

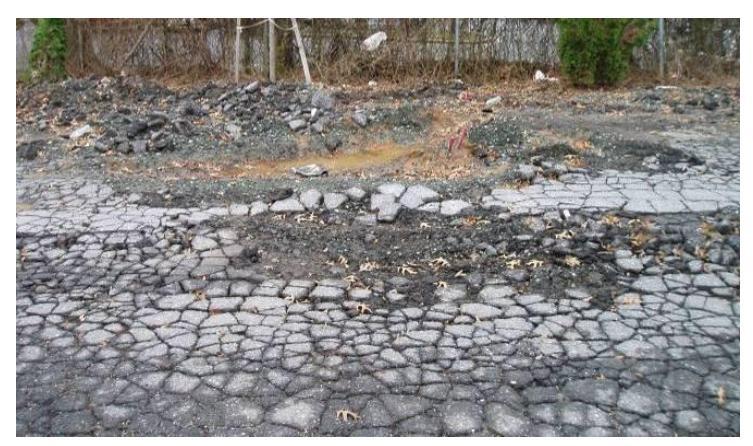
FIGURE 48: PARKING LOT IN NEED OF REPLACEMENT (H-101).

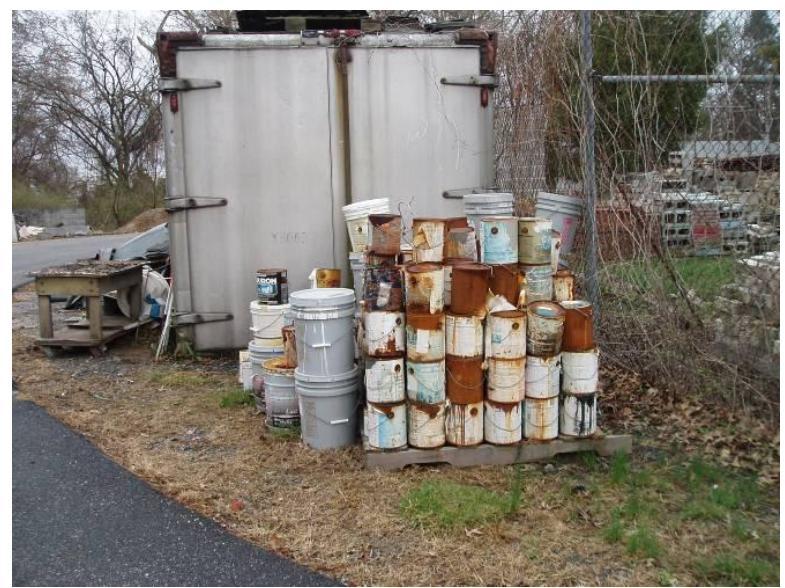
FIGURE 49: IMPROPERLY STORED OUTDOOR MATERIALS (H-103)

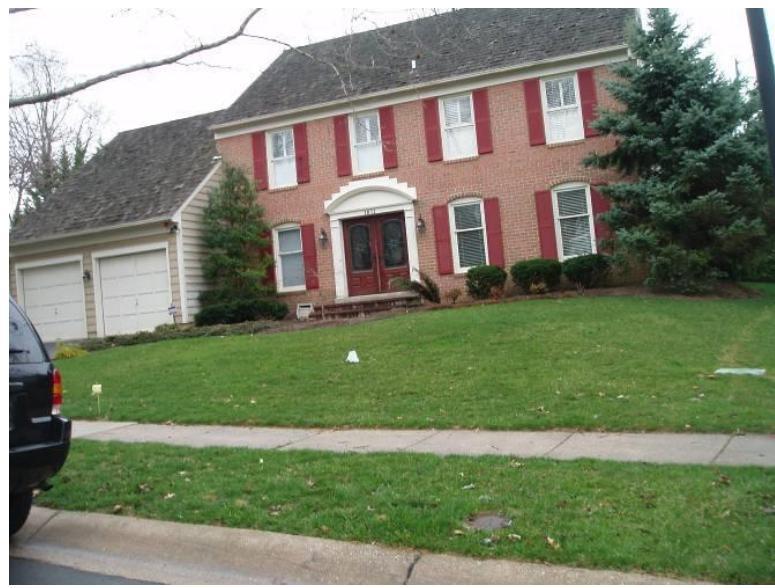
FIGURE 50: POTENTIAL HIGH MAINTENANCE LAWN (N-105)

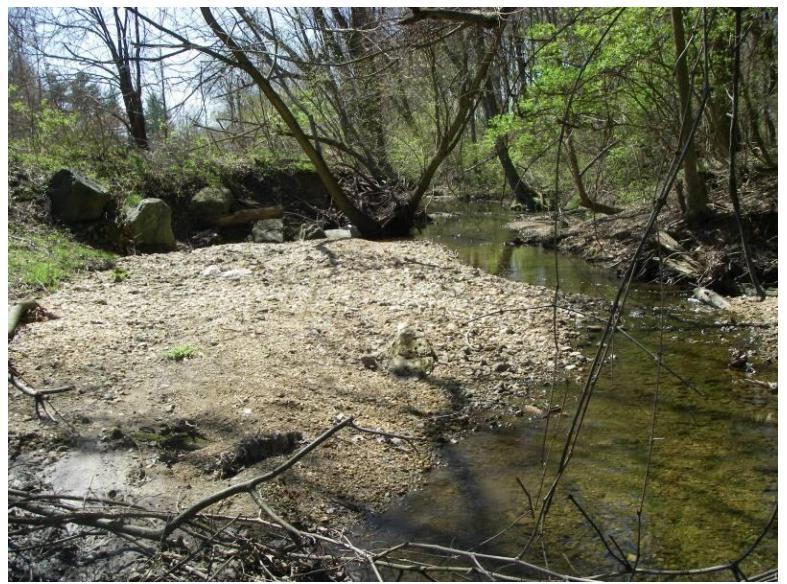
FIGURE 53: OVERWIDENED CHANNEL, WITH GRAVEL DEPOSITION (REACH UCJ-005)
