CABIN JOHN CREEK WATERSHED ASSESSMENT AND MANAGEMENT **RECOMMENDATIONS**

FINAL REPORT

ENVIRONMENTAL MANAGEMENT DIVISION DEPARTMENT OF PUBLIC WORKS CITY OF ROCKVILLE, MARYLAND

Approved July 18, 2011

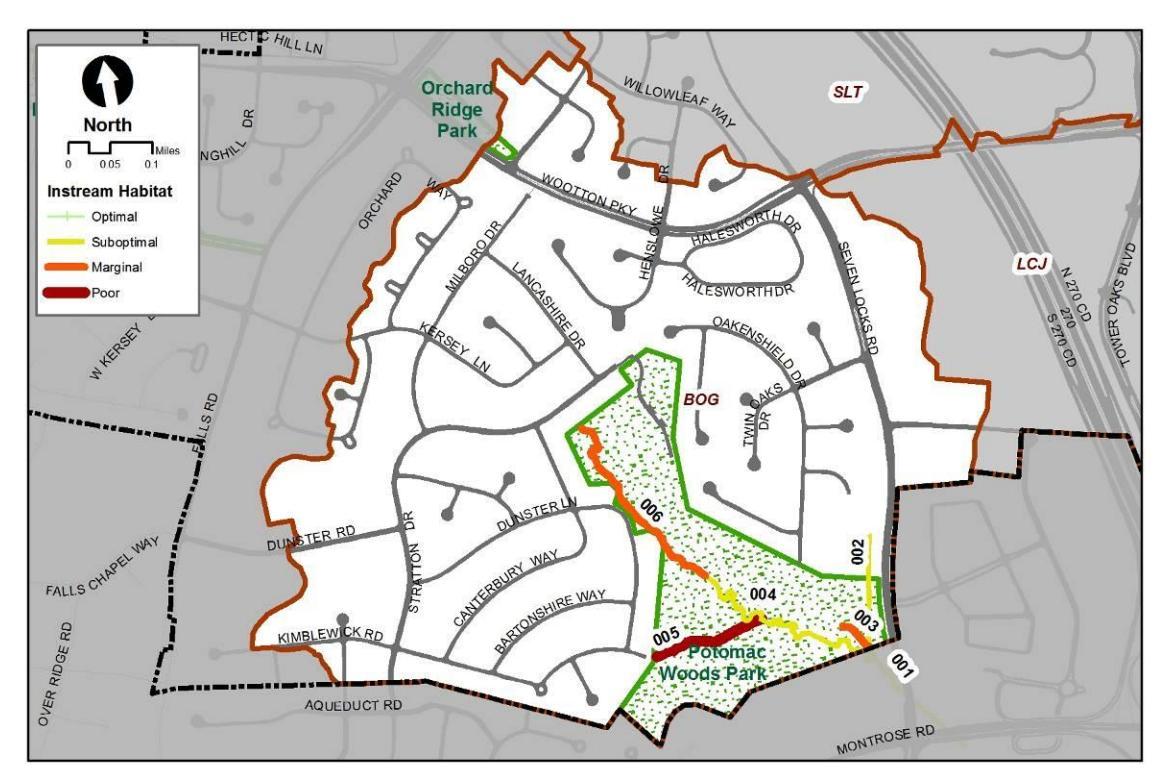
FIGURE 16: BOGLEY BRANCH HABITAT ASSESSMENT

The geomorphic assessment was performed on Reach 001 in the Bogley Branch sub-watershed just upstream of the City limits above Seven Locks Road. This reach is in transition from a C4 channel type at the downstream end to an F4 channel type at the upstream end. The C4 type is characterized as more stable with lower gradient and having good floodplain access.

Floodplain access was noted at the start of the assessed reach. Moderate to severe erosion was noted on outside meanders and large gravel dominated point bars were prevalent on inside meanders. One rock vane and one imbricated stone wall were noted at the most upstream portion of the assessed reach; however, no other stream restoration, stabilization, or bank armoring was present.

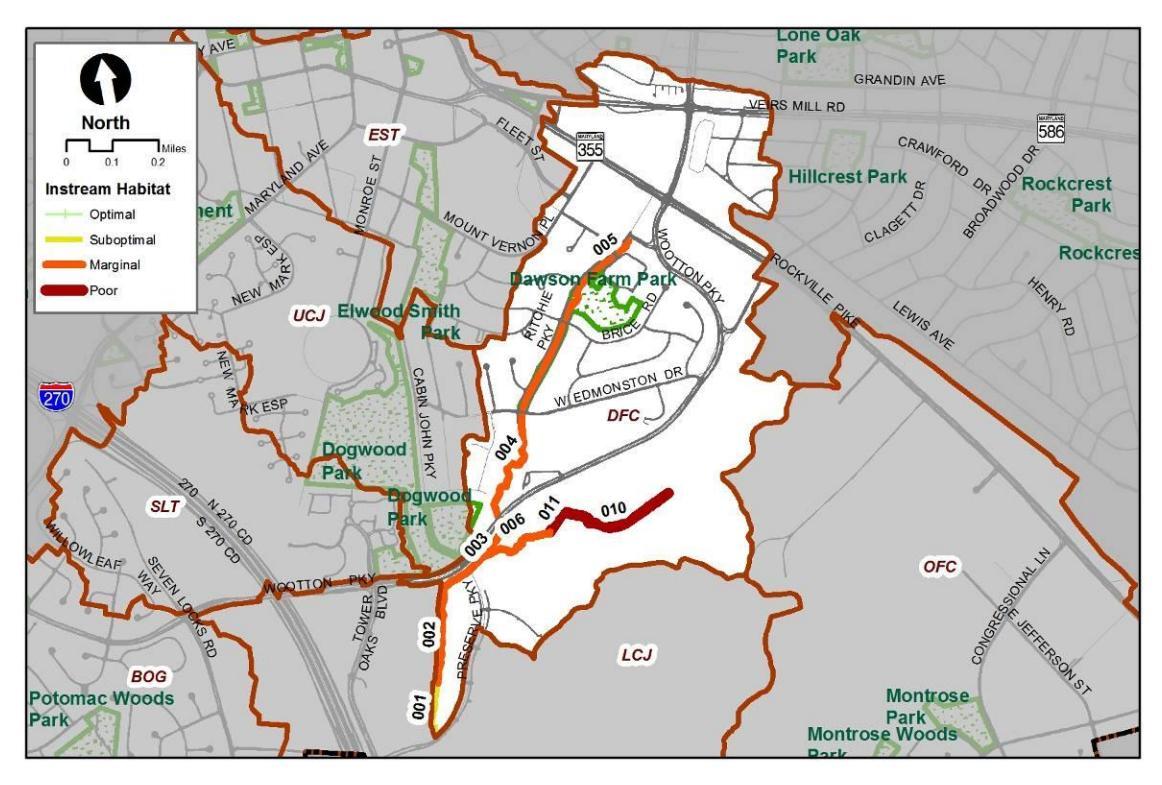
FIGURE 23: DAWSON FARM CREEK HABITAT ASSESSMENT

Reaches that are tributaries to the mainstem of Dawson Farm Creek are heavily impacted by practices at the Woodmont Country Club. Stream channels are generally stable with localized areas of erosion along outside meanders. Habitat is in the poor to low marginal range due to the amount of algae covering the channel bed and the lack of a sufficient riparian buffer. Along Reach 010, which lies between two fairways, all vegetation has been removed with the exception of several trees and it appears that herbicides have been applied along the stream banks to inhibit growth.

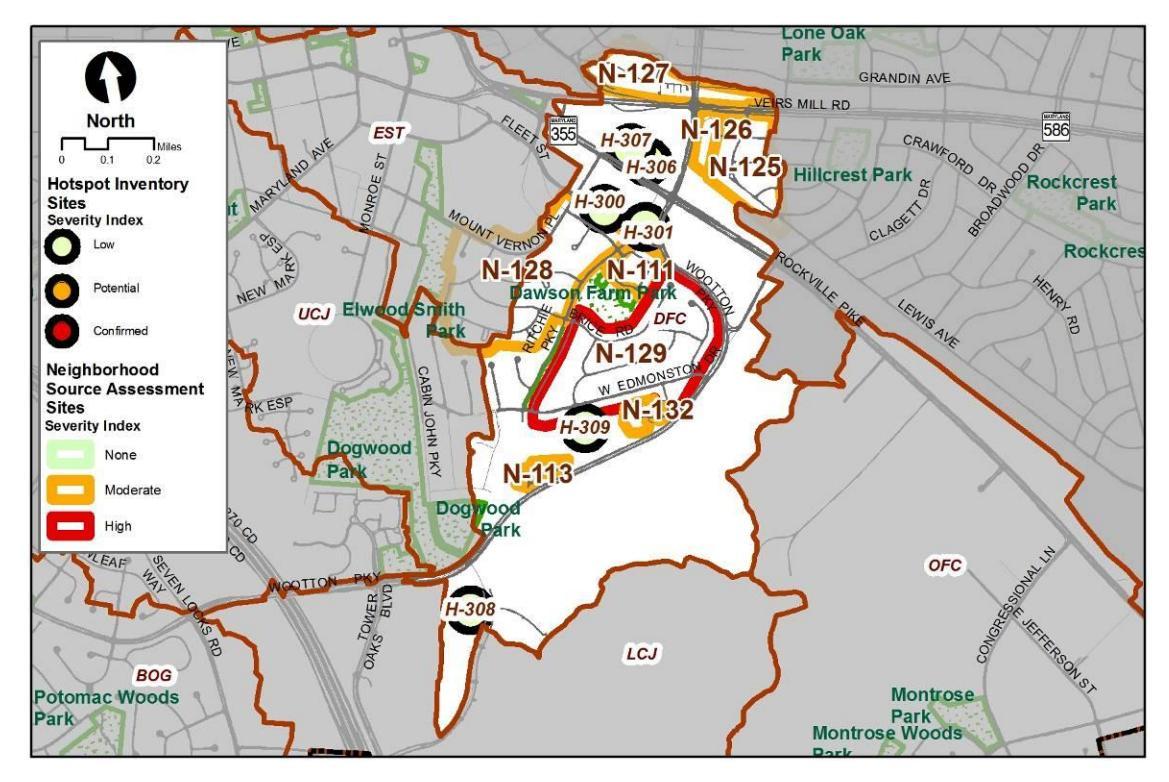
FIGURE 27: DAWSON FARM CREEK NSA / HSI RESULTS

Six hotspot sites and eight neighborhoods were assessed in Dawson Farm Creek. Five of the six hotspot sites were commercial areas and the sixth was an institutional use. The only hotspot activity noted was related to waste management, there were no vehicle operations or materials handling at any of the sites. Problems with waste management were noted at most of the sites, with either overflowing dumpsters or loose trash. A potential illicit discharge was found at site H-306, and evidence of discharging washwater into storm drains was seen at site H-308. Site H-300 was rated as a confirmed hotspot and all the others were rated low severity.

With one exception, downspouts were more disconnected in the older neighborhoods. Stormwater was conveyed through curb and gutter to inlets. No inlet stenciling or marking was observed. All the areas except one were rated moderate for both pollution potential and restoration opportunities.

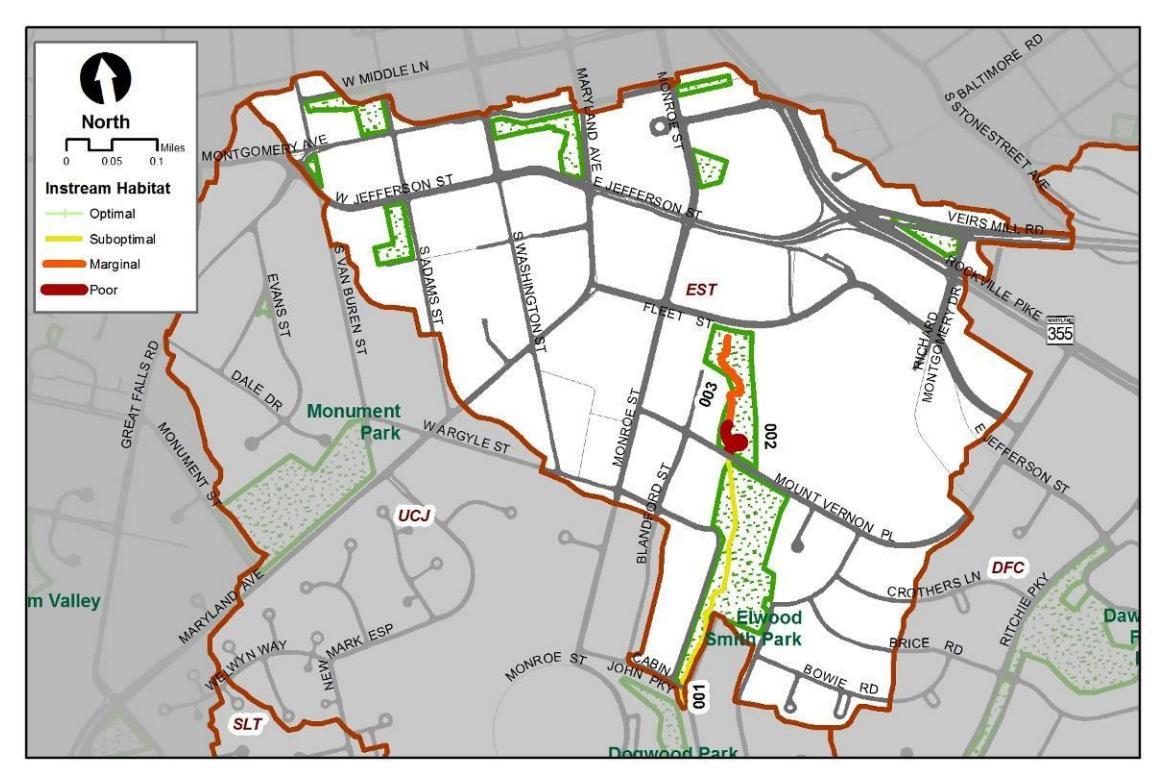
FIGURE 30: ELWOOD SMITH TRIBUTARY HABITAT ASSESSMENT

Generally, streams in the Elwood Smith Tributary sub-watershed are relatively stable with sections of active erosion. The overall assessment of the reach was that the active widening was the dominant process. Several outside meanders on Reach 001 have been armored and are in stable condition. Riparian buffer width varies along the length of the channel from good to poor and invasive species are prevalent. Stream habitat is in the mid-marginal to low-suboptimal range and the culvert at the downstream end of the mainstem (under Cabin John Parkway) is a fish blockage for all upstream reaches.

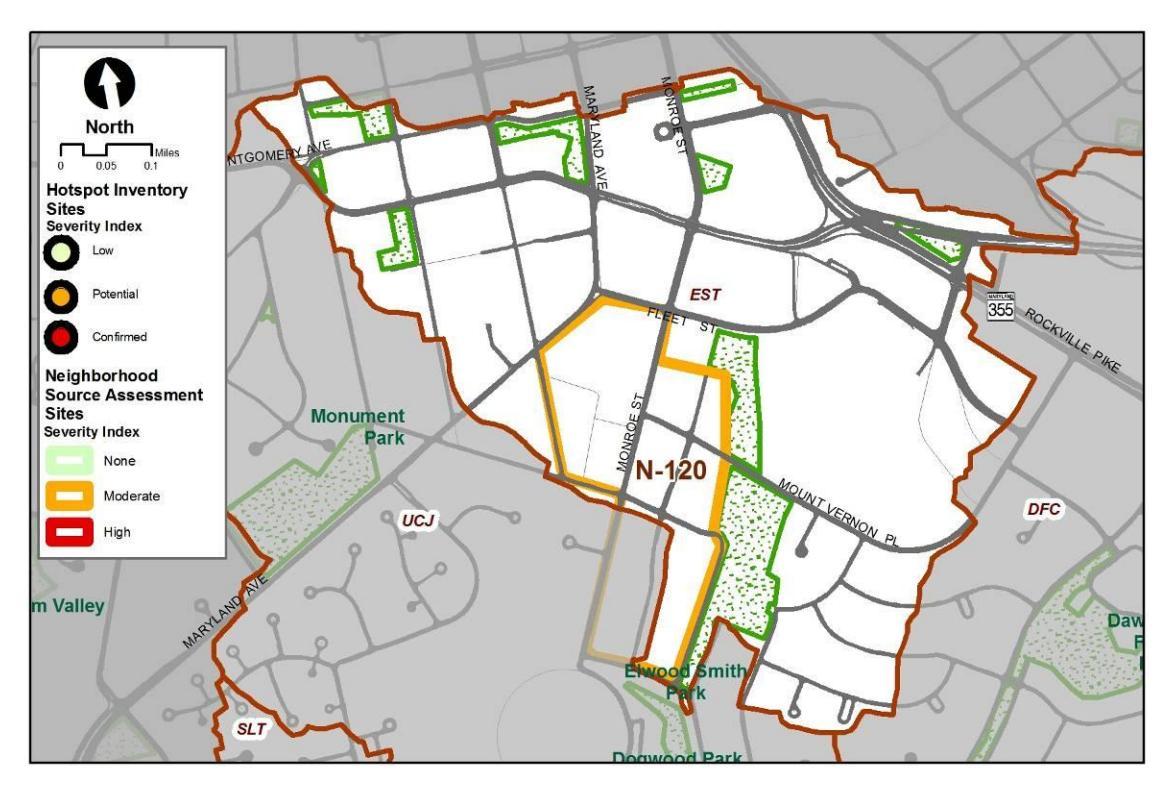
FIGURE 32: ELWOOD SMITH TRIBUTARY, NSA / HSI RESULTS

There were no hotspot sites and only one residential area assessed in this sub-watershed. While the residential area consisted of a mix of single-family detached and multi-family structures, built from the 1920s to the 1980s, the area assessed (N-120) was a uniform neighborhood of duplexes built in the

1950s. Lawn care practices were not a significant pollutant source, being primarily low maintenance. There was some evidence of trash and litter, and tree canopy was relatively low (less than 40 percent).

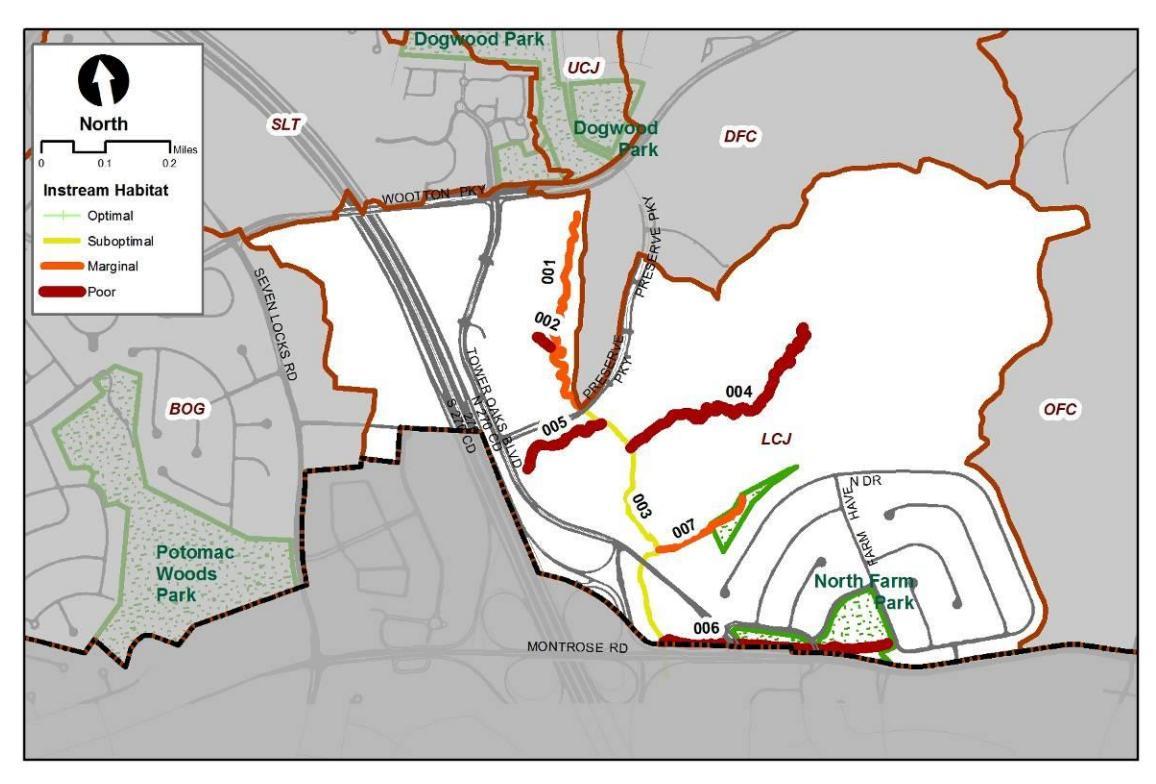
FIGURE 35: LOWER CABIN JOHN HABITAT ASSESSMENT

A geomorphic assessment was performed on Reach 001 of the Lower Cabin John Creek sub-watershed. Based on the surveyed information, this reach was identified as an F4 channel. The assessed reach is sinuous and overwidened with moderate to severe erosion on outside meanders. Large point bars with sand and gravel were prevalent. The channel is entrenched and overwidened with no apparent floodplain access even during high flow events. A resident is excavating portions of this surveyed reach with a shovel, effectively shortening meanders and creating a single long riffle instead of a riffle/pool morphology. This channel appears unstable and is moving large amounts of sediment during high flow events. No stream restoration, stabilization, or bank armoring was present in the assessed reach.

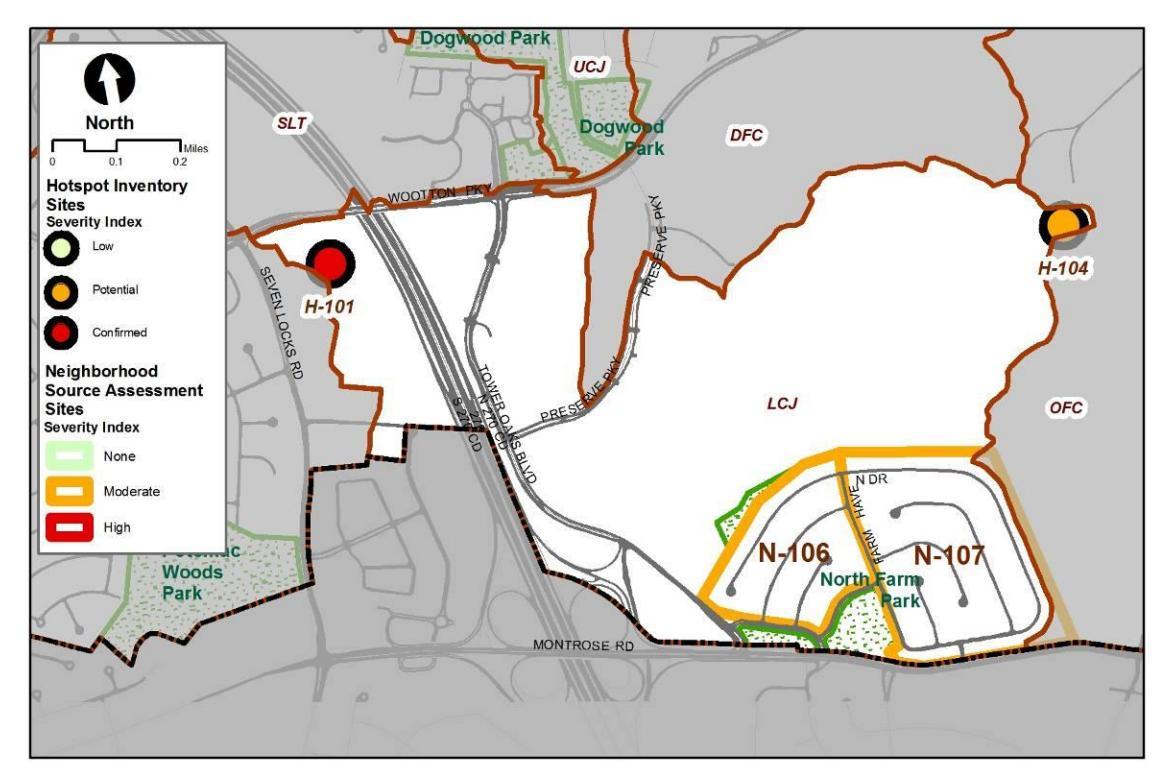
FIGURE 37: LOWER CABIN JOHN NSA / HSI RESULTS

Potential pollution sources for the vehicle shop included vehicle operations (repair, fueling, washing, and storage), outdoor gravel storage, and waste materials, garbage and construction materials, and the physical plant. Vehicles were stored outside, and leaks were observed. Dumpsters were overflowing. One parking lot was in poor enough condition to be contributing sediment when it rains. Severity was rated as confirmed.

The two NSA sites were part of the North Farm subdivision, a single-family detached development on 1/4 acre lots built in the late 1970s and 1980s. Very little infill or redevelopment was noted. All the lawns were maintained with either high or medium management status. A large percentage of the downspouts were disconnected from impervious surfaces. Some rain garden potential was noted in each neighborhood for treatment of rooftop, driveway and sidewalk runoff. Stormwater is conveyed through curb, gutter, inlets, and pipes, and a portion of the neighborhood is treated by an existing dry pond. They were both rated moderate for pollution potential.

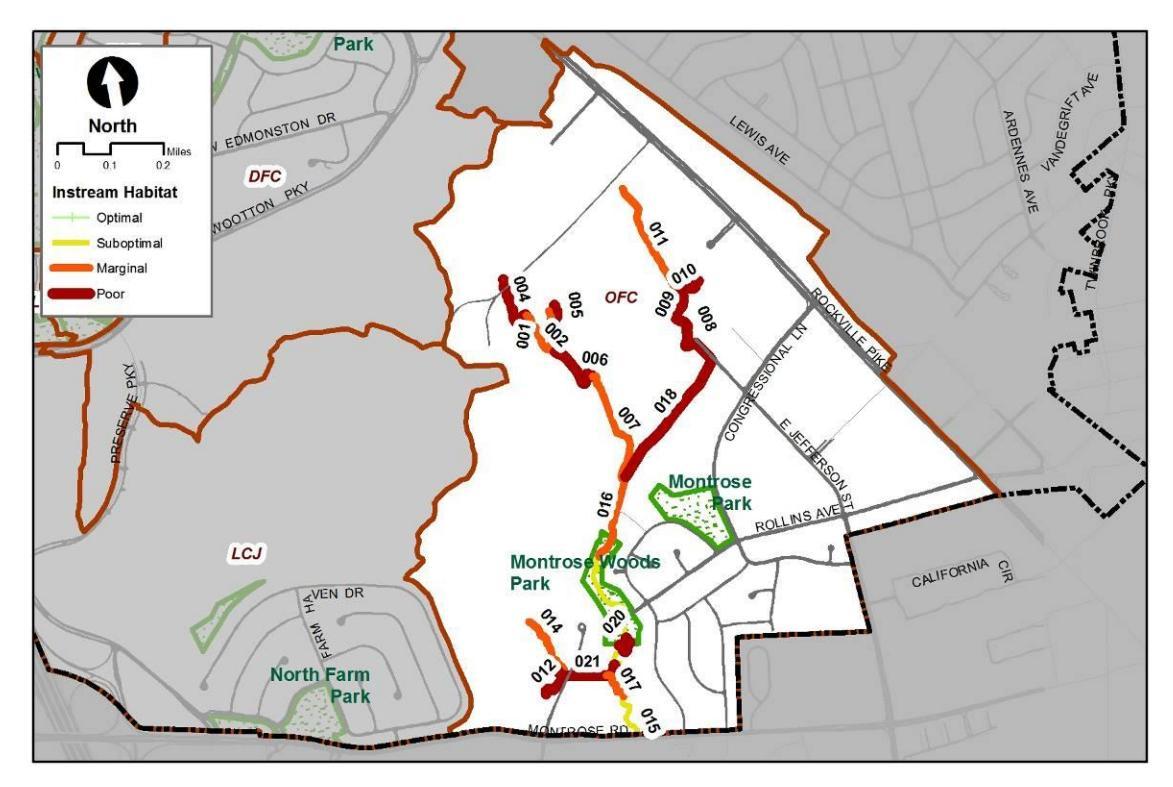
FIGURE 40: OLD FARM CREEK HABITAT ASSESSMENT

A geomorphic assessment was performed on Reach 015 in the Old Farm Creek sub-watershed. Based on the surveyed information, this reach was identified as an F4 channel. Although the assessed reach was classified as such, this reach differed from other F4 classified channels in the Cabin John watershed. This reach has low sinuosity and appeared mostly stable with only moderate erosion on one outside meander. Despite this stability, the channel is entrenched and overwidened with little floodplain access. Several bedrock outcrops were present in the channel bed and large gravel and small cobbles made up the substrate in the channel, which increases overall stability. Gravel and cobble bars were present, but were relatively small features within the channel. Riffles and runs dominated the reach as the channel had relatively steep slopes.

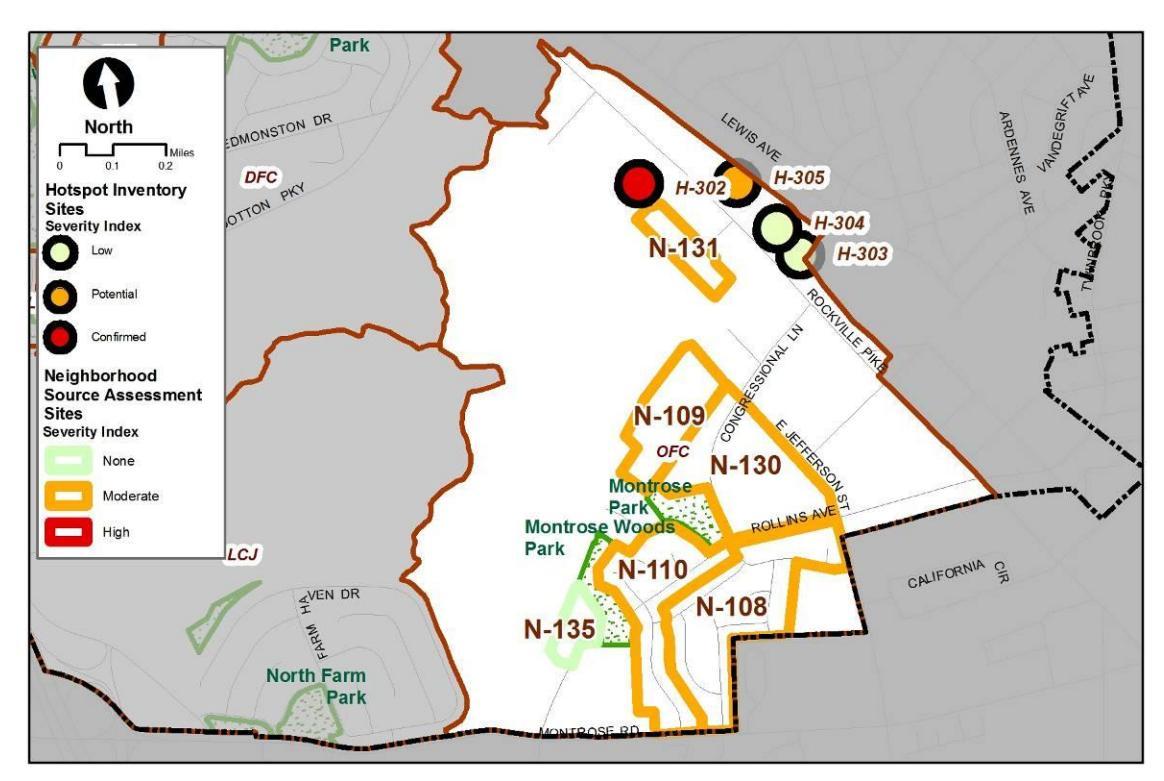
FIGURE 43: OLD FARM CREEK NSA / HSI RESULTS

The two single-family detached areas that were assessed were both part of the Montrose community and were adjacent to each other in the lower part of the watershed at the City line. Houses were built on 1/4 acre lots in the early 1960s. No evidence of infill or redevelopment was seen. Lawns were maintained well, but were not high-management status. Stormwater was conveyed through curb, gutter, inlets, and storm drains, and there did not appear to be any existing stormwater management facilities. None of the storm drain inlets were stenciled.

The four multi-family areas were situated throughout the watershed and were a mix of townhouses built in the 1980s, garden apartments and high-rise apartments built in the 1960s. All storm drainage was conveyed through curb, gutter, inlets, and storm drains. No inlets were stenciled. Lawns and common areas were well maintained, and no trash or pet waste was observed. Tree canopy was less than optimum at all the sites, which is to be expected for the higher density developments. However, it could be improved at the single-family residential areas N-108 and N-110. The newer developments were treated with stormwater management facilities. All six areas were rated with low or moderate severity for pollutants.

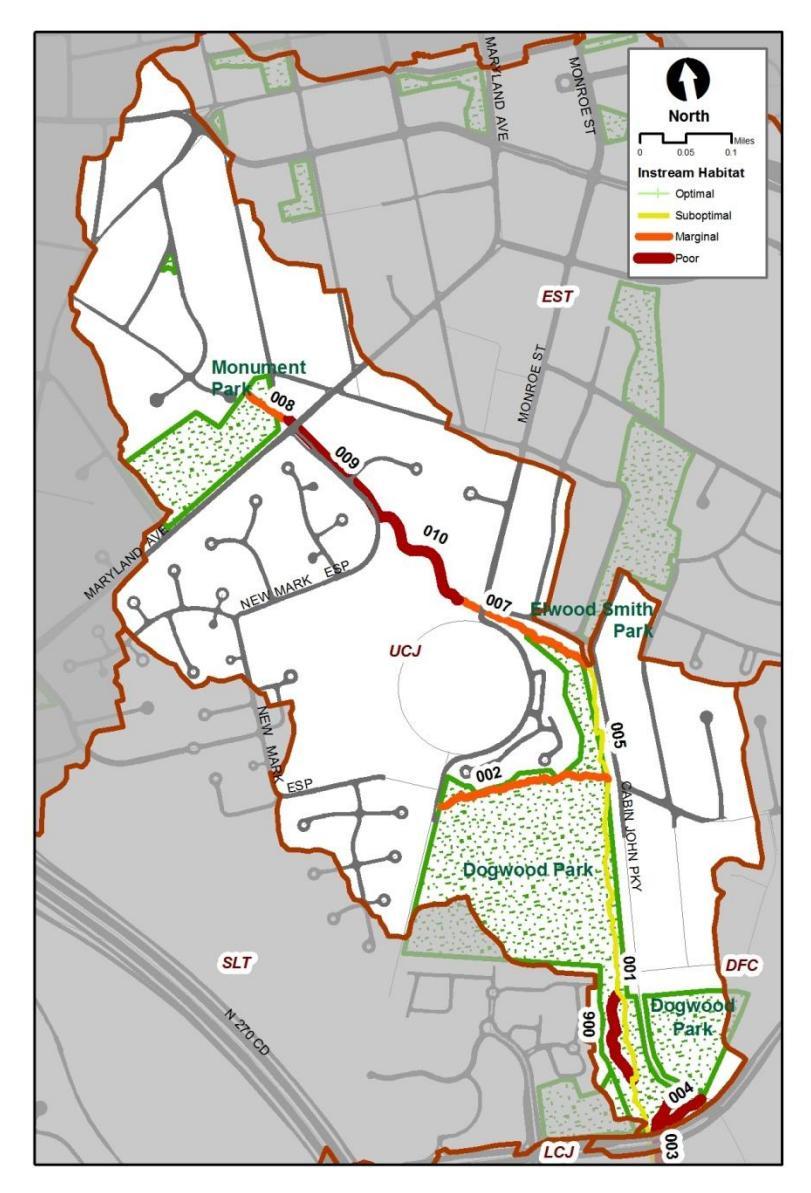
FIGURE 54: UPPER CABIN JOHN HABITAT ASSESSMENT

Tributary channels to the mainstem range from a good quality wetland (Reach 004) to piped reaches and trapezoidal channels. In general, channels are eroding and overwidened. Reach 002, specifically, is very unstable and experiencing extensive bank and bed erosion. Stream buffers through park areas are generally adequate but with areas where mowed grass is the dominant vegetation. Invasive species are prevalent, especially along Cabin John Parkway. Habitat ranged from poor to mid-marginal with areas of erosion, lack of habitat and algae negatively impacting habitat quality.

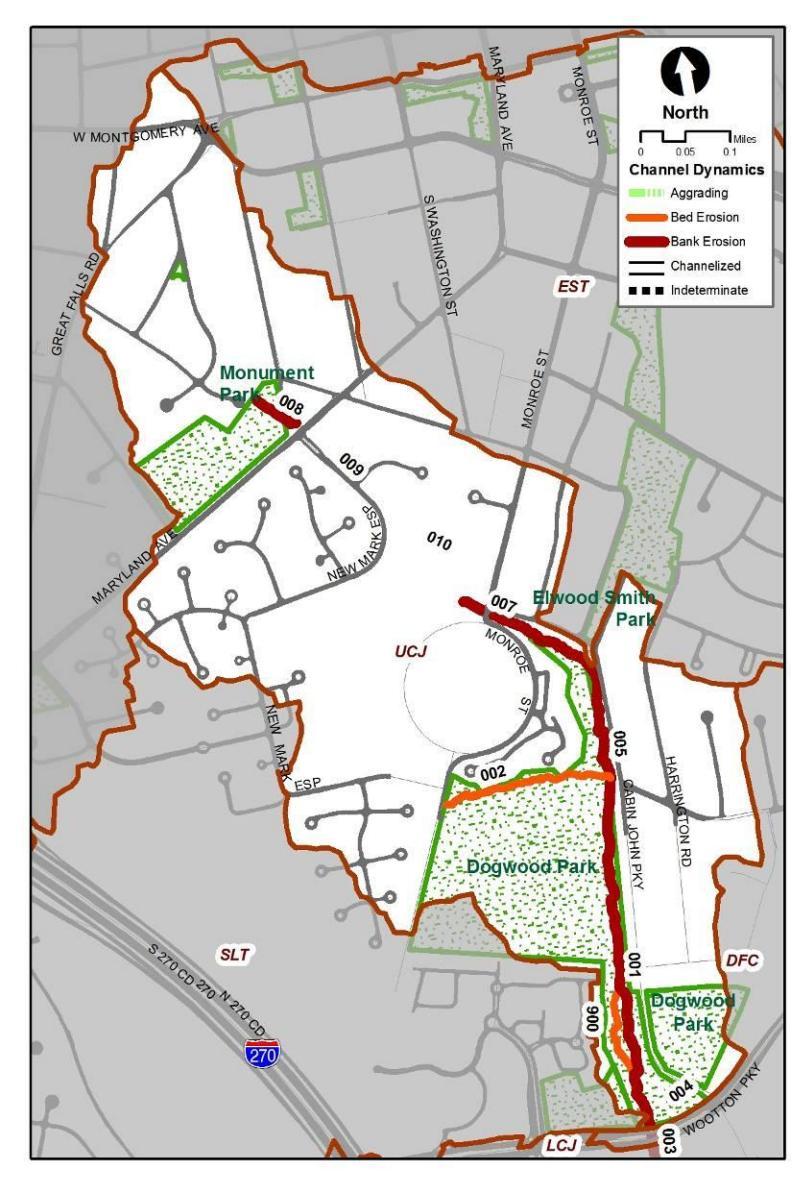
FIGURE 55: UPPER CABIN JOHN CHANNEL DYNAMICS ASSESSMENT

Geomorphic Assessment. A geomorphic assessment was performed on Reach 005 of the Upper Cabin John Creek sub-watershed. Based on the surveyed information, this reach was identified as a Rosgen type F4 channel. This reach differed from other F4 channels in the Cabin John watershed with very low sinuosity and appeared mostly stable with only minor erosion. Despite this stability, the channel is entrenched with no floodplain access. Several rock vanes and an occasional boulder/root wad restoration are present within the assessed reach and may be responsible for the stability. The riffle/pool morphology of this channel has been altered by the rock vane restoration in some areas. Portions of the channel between rock vanes have become long, shallow runs instead of riffles or pools. Gravel dominated the substrate in the channel and some gravel point bars were present in the channel.

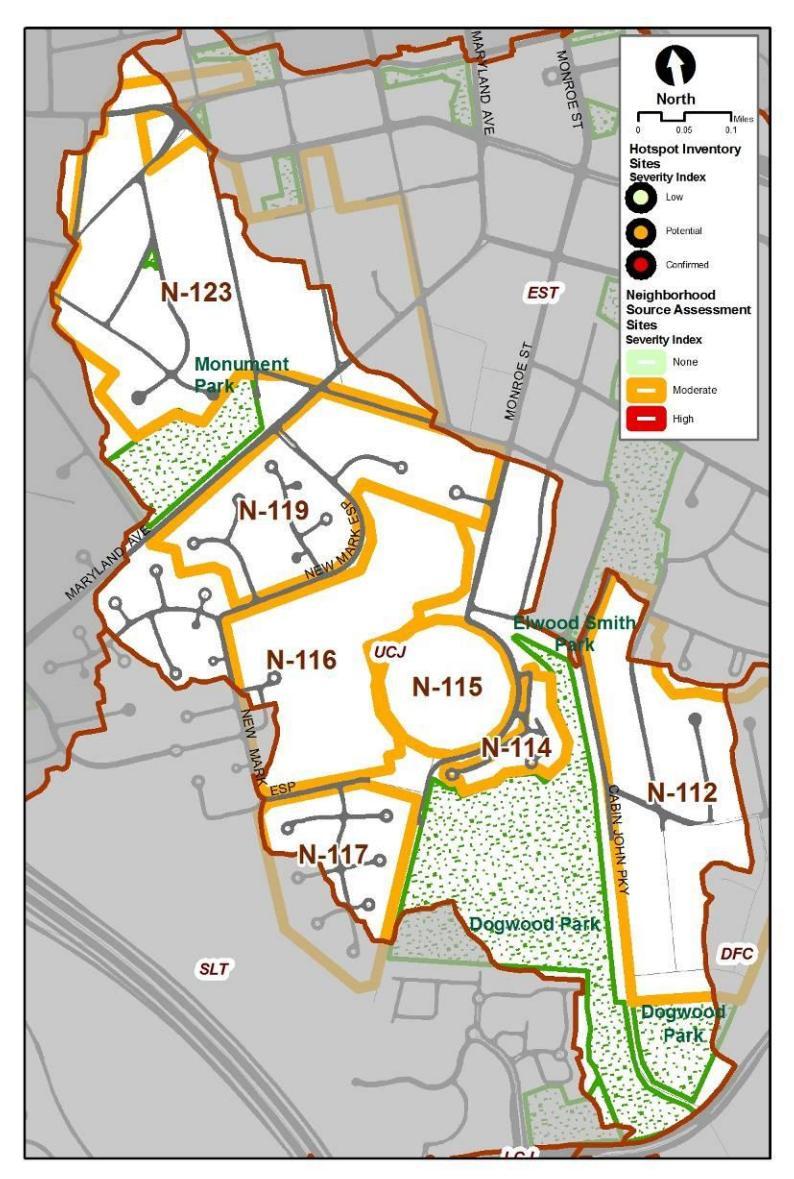
FIGURE 56: UPPER CABIN JOHN NSA / HSI RESULTS

Six residential areas were assessed in Upper Cabin John Creek. No hotspot sites were investigated because there is so little commercial or institutional land coverage. The residential areas consisted of a mix of single-family and multi-family developments at a variety of densities, built from the 1940s to the 1990s, with most of the development occurring in the 1960s and 1970s. Pollutant-causing behaviors and potential actions also varied widely across the different areas. Tree canopy was over 40 percent in all the single-family areas. Lawn care practices were primarily medium intensity, with lower impact on streams. Downspouts were over 40 percent disconnected in all neighborhoods except N-114. There were invasive species noted in Dogwood Park, adjacent to the neighborhood.

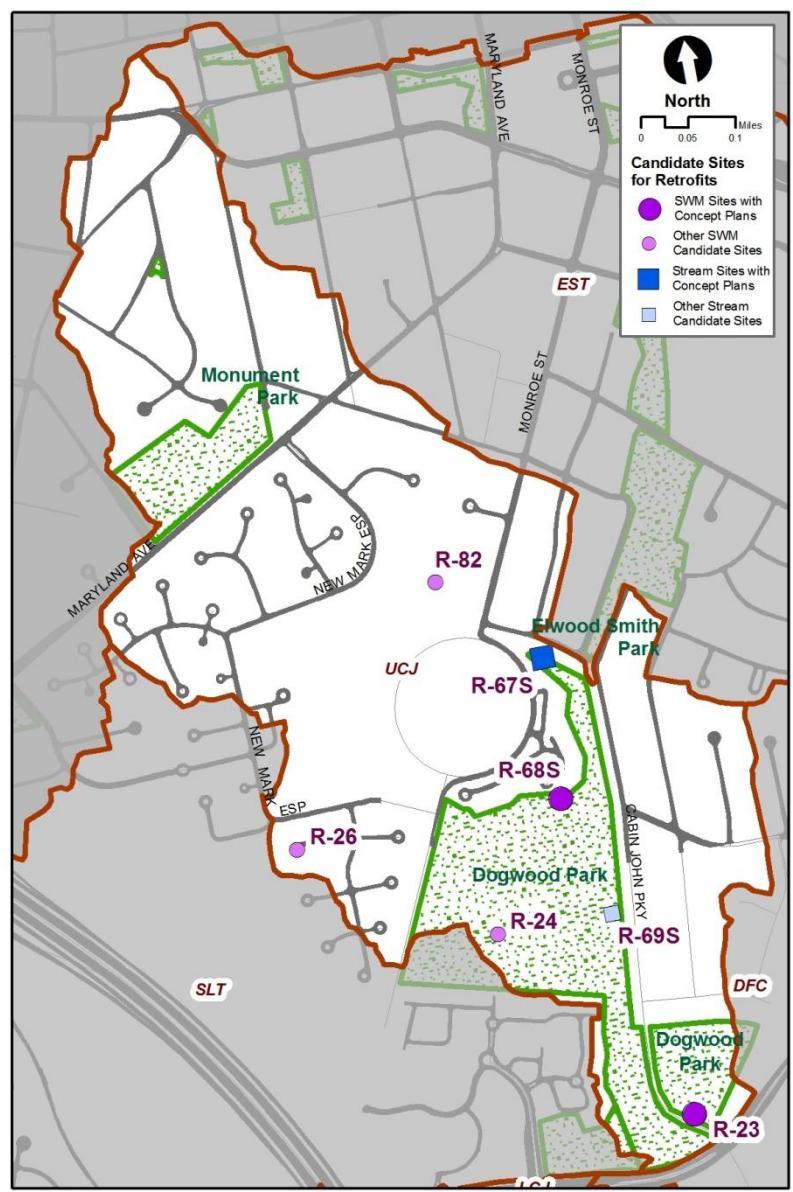
FIGURE 57: UPPER CABIN JOHN, CANDIDATE SITES FOR IMPROVEMENTS

The existing forebay volume may be undersized to current standards. The pond has accumulated at least one foot or more of sediment across the entire basin, which has caused the wetland marsh areas to lose proper depth and therefore shifted the planted zones to more upland species. This has disrupted the nutrient uptake as well as reduced storage volume, so the pond is not performing as designed.

- Restore actively eroding streams and protect vulnerable areas identified in the stream assessment. Three candidate sites for stream restoration were found: R-67S, R-68S, and R-69S.
- Identify water quality retrofit measures that could be implemented to treat runoff from areas with only quantity control. Candidate sites include pond retrofits R-23 and R-82, and parking lot and street retrofits R-24 and R-26;
- Invasive species removal, tree planting, downspout disconnection, and rain gardens were among the actions identified that neighbors can take to improve water quality in the sub-watershed. The Department of Recreation and Parks may also choose to expand the natural wooded stream buffer along Cabin John Parkway;
- Clean out accumulated sediment and vegetation from culvert system under Wootton Parkway to restore conveyance capacity in large storms and reduce available sediment load.

This project is recommended for major maintenance through the City's stormwater facility maintenance contract. The project will remove accumulated sediment across the forebay and main pond area, re-establish the wetland plants, and may regrade the basin to extend time between routine dredging and better maintain wetland functions. No change to the pond function is planned at this time. Coordination with the Department of Recreation and Parks and the surrounding neighbors will occur before the maintenance work is scheduled.
